**United States  
Department of the Interior**

**Aviation Safety Review  
Fiscal Year 04**

**Prepared by  
National Business Center  
Aviation Management Directorate  
Aviation Safety and Evaluation Division  
December 2004**

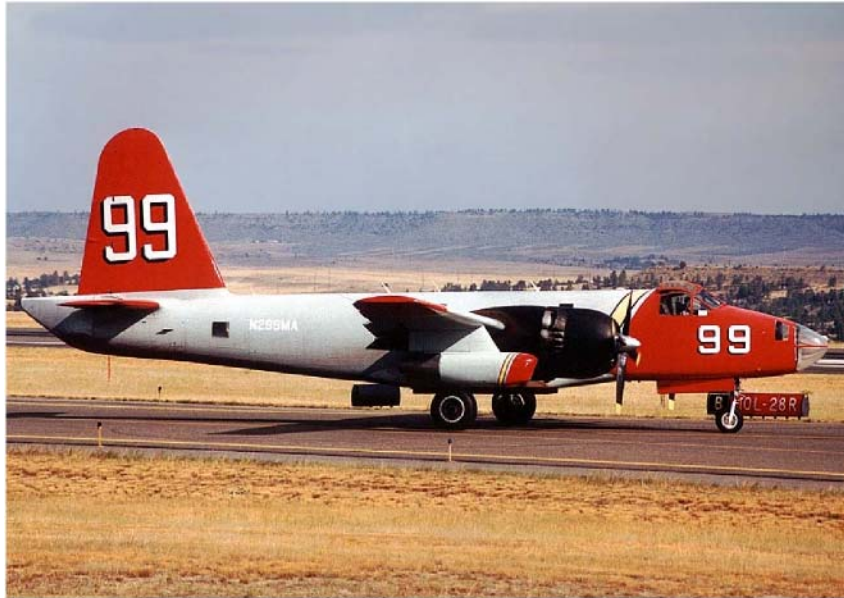
**AIRCRAFT ACCIDENT**  
**04-4F01-C-FNP**

**Narrative:** On October 3, 2003, at 1116 Pacific Daylight Time, a Lockheed P2V, N299MA, returning to the San Bernardino Air Tanker Base from a National Park Service mission, collided with terrain (N34°08.324' W117° 05.7') while maneuvering near East Highlands, California. The aircraft was destroyed and the two vendor pilots sustained fatal injuries.

Visual instrument meteorological conditions prevailed at the departure airport (Prescott, AZ) and throughout most of the flight route, however instrument meteorological conditions prevailed at the accident site.

The observers saw the airplane make a steeper than normal 180-degree turn and level out heading in the direction of the San Bernardino Air Tanker Base. They said that the aircraft appeared to be descending as it flew through one cloud, reappearing briefly, and then entering the cloud layer. About 2 minutes later, the observers saw the top of the cloud layer bulge and turn a darker color. The bulge began to subside and they observed several smaller bulges appear. They notified local authorities that they thought a plane was down.

Inadequate mission planning.

No evidence that pilots received a weather briefing.

Pilots must be encouraged to maintain instrument flight proficiency.

Pilots must avoid complacency regarding the risks of flight in limited visibility in mountainous terrain.

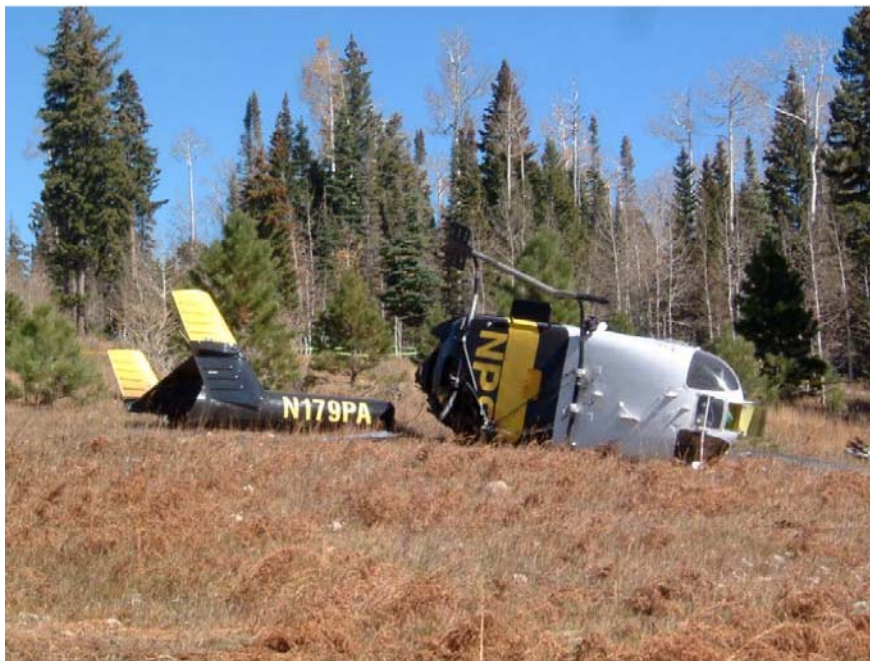
**AIRCRAFT ACCIDENT**  
**04-4F02-C-FNP**

**Narrative:** On October 16, 2003, at approximately 1650 Mountain Standard Time, the Grand Canyon National Park's exclusive-use MD 900 helicopter (N179PA) was substantially damaged when directional control was lost during the final stages of a landing to the Bear dip site. From approximately 30 feet above ground level (AGL) the helicopter spun violently to the right for at least two revolutions before the pilot was able to set the aircraft on the ground. Due to the rapid rotation and the uneven surface the aircraft rolled onto its left side. There were no injuries and the crew was able to aid the passengers in exiting the aircraft. Laboratory analysis indicates that a fatigue fracture resulted in the separation of a control rod inside the Fan Input Force Limiting Control Rod Spring Capsule. Failure of this control rod resulted in the NOTAR fan blades moving to a neutral pitch setting. The neutral pitch of the NOTAR fan blades reduced the volume of air flowing through the NOTAR tail boom reducing the effectiveness of the slotted tail boom's Coanda effect. As the aircraft began to yaw to the right the pilot appropriately applied left pedal, which rotated the thruster to the left. The rotation of the thruster opened a path for the low-pressure high-volume air remaining in the tail boom (previously produced by the NOTAR fan) to escape from the thruster without providing any effective anti-torque action. This loss of anti-torque control at a critical moment in the helicopter's approach, and in a physical location that did not provide any avenue for escape made the resulting crash inevitable. Upon identification of a material failure of the control rod, the investigator's focus shifted to engineering fixes by MD Helicopters and oversight by the Federal Aviation Administration. This investigation identified no deficiency on the part of the National Park Service, the vendor, or the pilot. On the contrary, the pilot's conservative approach, calm reaction to stress, and outstanding airmanship undoubtedly minimized damage and prevented loss of life. Similarly, the Park's coordinated and professional response to the emergency was exemplary, as was the vendor's cooperation and support during the investigation.

The exceptional skill and conservative flight profile allowed the pilot to prevent injury to his passengers and minimize damage to his aircraft.

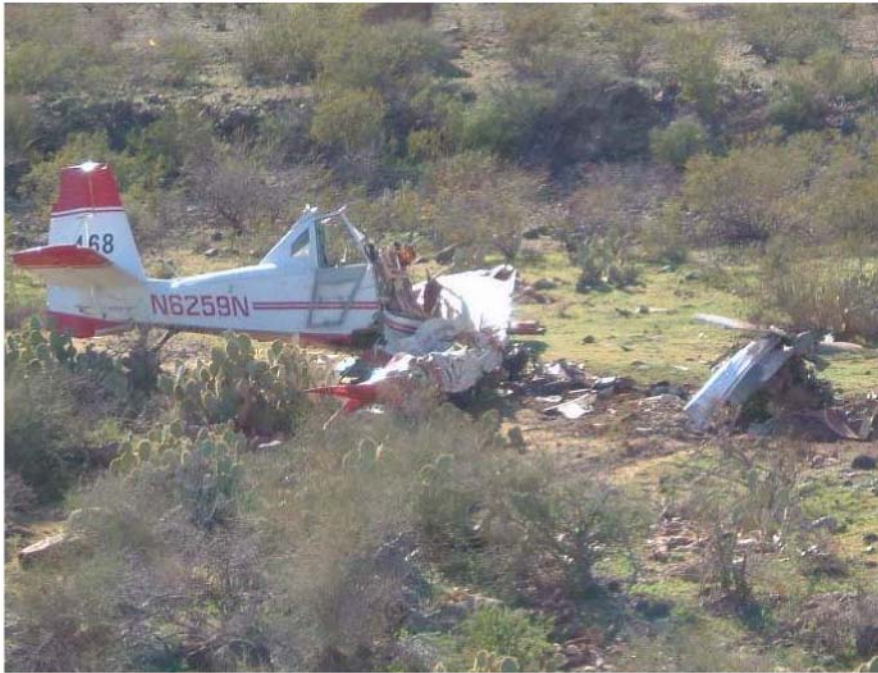
**AIRCRAFT ACCIDENT**  
**04-4F03-C-LLM**

**Narrative:** On March 16, 2004, about 0935 Mountain Standard Time Tanker 468, a Wsk Pzl Mielec, M-18A, (Dromader) N6259N, was destroyed and the vendor pilot sustained fatal injuries when the aircraft impacted terrain about 12 nautical miles east-northeast of Safford, Arizona (N32° 52.01' W109° 23.55'). The mishap pilot was participating in a Bureau of Land Management (BLM) managed Single-Engine Air Tanker (SEAT) pilot training program (commonly referred to as the SEAT Academy) in Safford, Arizona. The scenario at the time of the accident had the pilot receiving an in-flight mission change to test the pilot's ability to handle multiple tasks and re-program the radios and GPS in flight while enroute to a fire. Witnesses reported that the airplane was loaded with 400 gallons of water in preparation for a practice simulated fire retardant drop. A BLM employee simulating the role of a fire Incident Commander (IC) described the training scenario as "operations normal" as the accident airplane maneuvered on the downwind leg of the flight pattern. The pilot transmitted a request to the IC to perform a "dry run" prior to dropping his load of water on the simulated fire. The pilot was observed to extend his downwind leg. While turning left to the base leg, the airplane's engine was heard to "surge" two to three times. Witnesses stated that the airplane assumed an "unusual attitude" with "the right wing up and the nose down" until they lost sight of the airplane behind a small ridgeline.

Physical evidence at the crash site indicates that the aircraft impacted the ground in a near vertical, nose-low attitude. Environmental effects of weather and terrain were not considered significant to this accident. Investigators found no evidence of any pre-impact mechanical defects with the aircraft. Additionally, none of the pilots who had flown the aircraft recently could recall any deficiencies with the aircraft, with the exception that one pilot recalled that this aircraft used more fuel out of it's left tank than out of the right tank.

Inspection of the flight control system established continuity to the rudder and elevator. However, impact forces severed the flight control linkages from the cockpit to the ailerons. Refueling records and witness statements indicate that N6259N had been fully fueled by the previous pilot and the mishap pilot was observed to have physically checked at least the level of the left wing tank when he preflighted the aircraft on Sunday, March 14, 2004. A sample of fuel from the refueling source was tested and determined to be “on grade”. A sample from the left wing could not be tested completely due to the very small quantity available and resulted in “failed specs”. Witnesses observed the mishap pilot fly the aircraft approximately 30-45 minutes on Monday evening, March 15<sup>th</sup>. Dispatch logs recorded the mishap pilot’s takeoff on Tuesday, March 16<sup>th</sup> at 0835 hours and the call from the ground observer to shut down the training as a result of the crash at 0935 hours. This indicates that the aircraft had been operated between 1 hour and 30 and 1 hour and 45 minutes (1.5-1.8 hours) and should have had more than an hour’s worth of fuel remaining. Although initial responders recalled smelling fuel at the accident site on-site inspection of right and left fuel tanks via the fuel filler caps and fuel drains revealed no fuel present. The header tank, which is fed by both main fuel tanks and in turn provides fuel to the engine, also contained no fuel. Impact damage ruptured the right wing’s fuel tank while the left wing’s fuel tank and the header tank were intact and held water when tested. The M-18 Flight Manual, Section 4 Normal Procedures, paragraph 4-10 Level Flight, warns pilots against allowing an imbalance in fuel quantity between the right and left fuel tanks. Many of the Dromader pilots interviewed during this investigation had personally experienced an engine failure from this type of fuel imbalance during agricultural flying. According to the M-18 Flight Manual (paragraph 3.4(f)) pilots attempting to restart the engine following a fuel starvation caused engine failure should expect a loss of at least 656 feet (200 meters). Therefore, unless a fuel starvation caused engine failure occurs at enroute altitude the pilot should focus on making an emergency landing rather than trying to restart the engine. Teardown analysis of the engine found no evidence of any pre-impact mechanical defects and the engine appeared to have been operating at low power/RPM at the time of the impact. The investigation did not find proper documentation for the propeller configuration on the aircraft at the time of the accident. The propeller is not suspected of having played a causal role in this accident. The mishap pilot had logged 17,500 total flight hours of which 550 were in the M-18. The pilot’s Interagency Airplane Pilot Qualification Card was expired at the time of the accident however; since the pilots and aircraft participating at the SEAT Academy were not contracted there was no specific requirement for either pilot or aircraft to be carded.

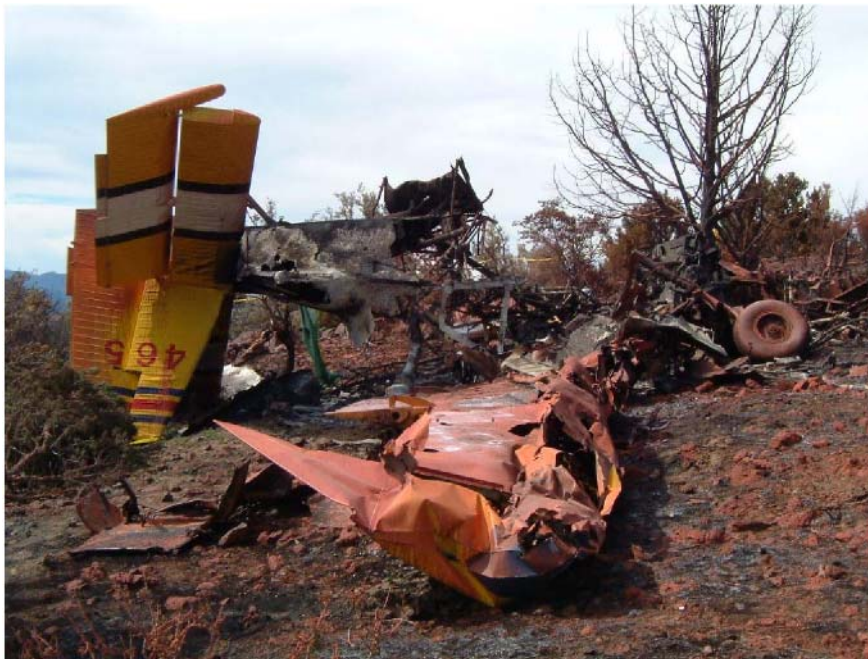
**AIRCRAFT ACCIDENT**  
**04-4F04-C-LLM**

**Narrative:** On June 17, 2004, at 1746 Mountain Standard Time, Tanker 465, a Wsk Pzl Mielec, M-18A, (Dromader) single-engine air tanker (SEAT) N8214J, operated by the Bureau of Land Management (BLM) was destroyed and the vendor pilot sustained fatal injuries when the aircraft collided with the terrain (37° 19.562' W113° 36.818') following a fire retardant drop near St. George, Utah. Visual meteorological conditions prevailed at the time of the accident and environmental effects of terrain are not considered significant in this accident. Physical evidence at the site indicates that the aircraft impacted the ground in a near vertical, nose-down attitude. No evidence of an in-flight structural failure, flight control discrepancy, or obvious catastrophic engine failure was noted at the site. Subsequent teardown analysis of the engine revealed no pre-impact mechanical defects and clear indications that the engine was producing relatively high power/high RPM at impact. The airplane maintenance records were on board the airplane at the time of the accident and were destroyed in the post-crash fire. The mishap pilot was acting as a relief pilot at the time of the accident. The primary pilot, who had flown the accident airplane for three years, reported no problems with the airplane prior to the accident. The mishap pilot was highly experienced in agricultural aircraft with over 21,000 total flight hours. However, this was the pilot's first fire season and his experience in the M-18 was estimated to be approximately 50 hours. Prior to the accident the pilot had made several retardant drops out of St. George and was described by witnesses as being careful to put his retardant precisely where it was requested. On the mishap drop the pilot was flying a left-hand pattern and had been directed by air attack to "tag onto" the existing fire line heading approximately 218 degrees. The drop altitude was about 100 feet above ground level (AGL), and the ground sloped downward about 20 degrees through the drop zone. The air attack said that the pilot called for an initial dry run to be followed by the drop of approximately 500 gallons of retardant. On the second pass the pilot radioed air attack and said that he overshot the final and was going around for another attempt. On the third approach the pilot called downwind, base, and final but made no other transmissions to indicate that he was having a problem.

Ground witnesses and the air attack observed the retardant exit the airplane early of the desired point and not distributed in an even line. Shortly after the drop the nose of the airplane was observed to pitch up slightly, then to pitch down approximately 45 degrees until ground impact. After impact other aircraft in the immediate area were directed to drop their retardant on the wreckage to aid in extinguishing the post-crash fire. Following the accident pilots with various amounts of experience in the M-18 Dromader were interviewed. Most of the pilots have individual techniques on how to fly the aircraft during a retardant drop depending upon the situation (i.e. environment, terrain, load, type of fire, type of gate, etc.), which in turn affects the type of approach, trim and flap settings, and the airspeed that the pilot will use. The majority of the airspeeds described for the retardant drops were below the placarded limits published in the M-18 Aircraft Flight Manual. The M-18 pilots said that the slower airspeeds were used to compensate for an abrupt pitch up of the aircraft's nose as the load of retardant was released. The pitch up of the nose is caused by the aircraft's center of gravity shifting aft as the load is suddenly released causing the airspeed to decrease by as much as 10 miles per hour (MPH). Flying at airspeeds below those required by the Aircraft Flight Manual, in potentially turbulent air and experiencing the loss of airspeed from the nose pitching up can place the aircraft at or near its stall speed. Very few of the M-18 pilots interviewed had ever practiced a stall in the M-18. Each pilot had their own recovery technique and the consensus was that it was a learned skill that had to be developed with time in the aircraft. Individuals with less experience in the M-18 such as the mishap pilot can easily get behind while flying the aircraft enabling a situation to develop that can be difficult to arrest especially at low altitudes. As a result, the National SEAT Program Manager temporarily stood down operation of all 26 contracted Dromader M-18 airplanes so that pilots could "review published charts and flight manuals pertaining to drop speeds for the PZL M-18 Dromader aircraft models A and B equipped with either piston or turbine engines, at the weights common to fire suppression operations."

-Recommendation for pilots to review aircraft-specific drop airspeeds.

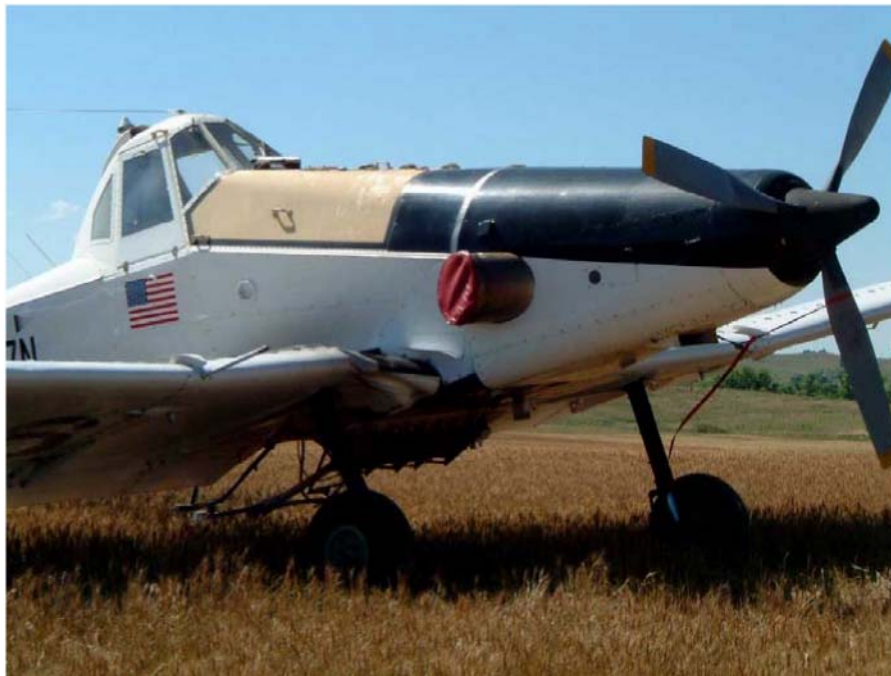
**AIRCRAFT ACCIDENT**  
**04-4F05-C-BIA**

**Narrative:** On July 11, 2004, at 1925 Mountain Daylight Time, a Pzl Mielec M-18T, N7077N, operated by the Bureau of Indian Affairs (BIA), sustained substantial damage during a forced landing to a rolling wheat field (N43° 01.07' W102° 32.18') near Pine Ridge, South Dakota. The vendor pilot was not injured. Visual meteorological conditions prevailed at the time of the accident. The area was free of obstructions with the exception of a power line running north-south, perpendicular to the aircraft's flight path, located approximately 500 feet east of the aircraft's termination point. While returning from a retardant drop the pilot began a descent from cruise flight to enter the traffic pattern at 120 mph. As the pilot approached the field he slowed the aircraft and reduced the power to the flight idle position with the intent of entering downwind for runway 30. At that time the pilot observed the propeller over speed light (N2 compressor) illuminate. The pilot stated that the maximum operational speed of N2 (1720 rpm) was exceeded. As he continued to descend the N2 speed climbed to 1850 rpm so the pilot reduced the power to 91 percent and maintained the descent. The pilot noticed that after the power was reduced the aircraft was only indicating 17 PSI of torque. Attempts to control the descent with power resulted in over-speeding the engine without decreasing the rate of descent. The pilot, realizing that he could not make runway 30, adjusted to land on runway 06 but the aircraft continued to descend and the pilot was forced to land in a rolling wheat field 1/2 mile west of runway 06. The landing resulted in the right main landing gear being forced up into the wing damaging both the wing and the center section. No deficiencies were noted in either the pilot's qualifications or performance during this emergency. The propeller control assembly was disassembled and inspected at Pacific Propeller Inc. and was found to be heavily contaminated with debris, which clogged all of the internal filters. This resulted in a pressure differential between the pressure and return sides of the propeller control causing the propeller to "lock".

Operators should use the manufacturer's recommended hydraulic fluid in the propeller control unit in conjunction with either an oil change schedule or an oil analysis program.

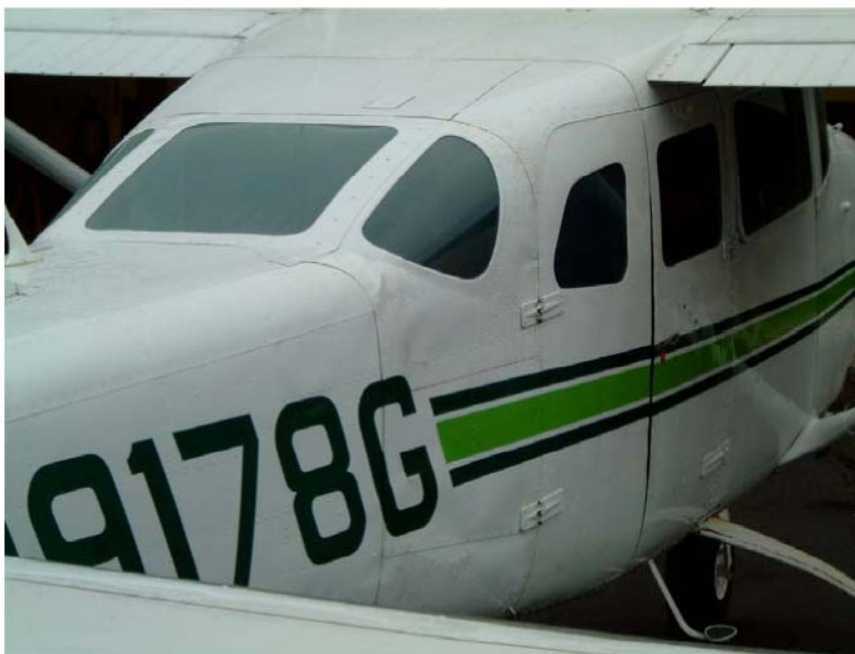
**AIRCRAFT ACCIDENT**  
**04-4F05-C-BIA**

**Narrative** On July 29, 2004, about 1000 Alaska Daylight Time, a Cessna U206G airplane, N9178G, operated by the National Park Service (NPS) sustained substantial damage when the aft cargo door came open during the takeoff roll, and damaged the fuselage at the Yakutat Airport, Yakutat, Alaska. The NPS pilot and his sole passenger were not injured. The pilot stated that when the door inadvertently opened on the takeoff a cardboard box containing a laptop computer fell out of the aircraft onto the runway. The pilot aborted the takeoff and back-taxied down the runway and retrieved the box. He then taxied off of the runway to the tarmac area where he shut the aircraft down and checked the door and fuselage but did not see significant damage. After checking the doors, the hinges, the locking mechanisms, and seeing that the doors would lock, the pilot continued with his mission that day. The pilot continued flying missions in N9178G until DOI-AM maintenance personnel noticed the damage during a 100-hour inspection on or about August 20, 2004. Although the pilot stated in his interview that he was certain that he had secured the cargo door the investigation concluded that there was no mechanical defect in the cargo door system and if the aft cargo door had been properly closed, latched, and locked it could not have inadvertently opened. It is believed that the pilot unintentionally failed to fully close the aft cargo door by placing the aft cargo door handle in the closed position while the upper and lower hooks were outboard of the latch plates. This allowed the aft cargo door to feel tight and secure without being locked. With the aft cargo door in this tight but unlocked condition the pilot closed the forward cargo door believing that it was locked. During his pre-takeoff cockpit procedures the pilot checked to see that the cargo door's inside handle was in the locked position and proceeded with the takeoff. During the takeoff roll the cargo door opened and damaged the fuselage. It is likely that the unsecured box containing the laptop computer hit the cargo door, causing it to open. Environmental effects of weather and terrain were not considered significant to this accident.

A review of OAS-2s for N9178G for the period of July 19-30 revealed no entry describing either the cargo door inadvertently opening, damage to the fuselage, or any operations at Yakutat. A SAFECOM was not filed at the time of the event.

Aircraft damage must be inspected and approved by a certified aviation mechanic prior to being returned to service.

Pilots must understand and accept the responsibility to submit a SAFECOM when the aircraft is damaged, or when an unexpected event occurs such as the inadvertent opening of the cargo door.
